Understanding Silicone Peeling in Stainless Steel Tank Pools

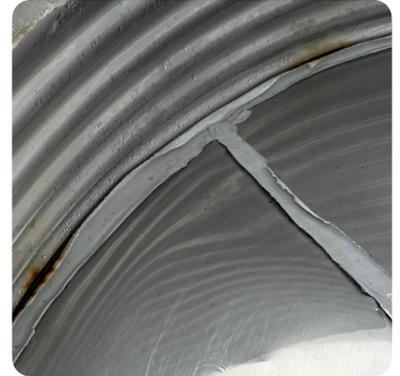
Silicone plays a crucial role in sealing and protecting stainless steel tank pools—especially around joints, seams, and fittings. However, under certain conditions, silicone can begin to peel away from surfaces, leading to leaks, contamination, or aesthetic issues. Knowing how to identify, prevent, and treat silicone peeling helps protect your investment and keep your pool safe and sealed.

- Visible lifting or curling at silicone edges
- Gaps forming between silicone and steel
- Discolouration, cracking, or chalking of the silicone
- Water seepage around fittings or seams
- Visible water around the base of the pool

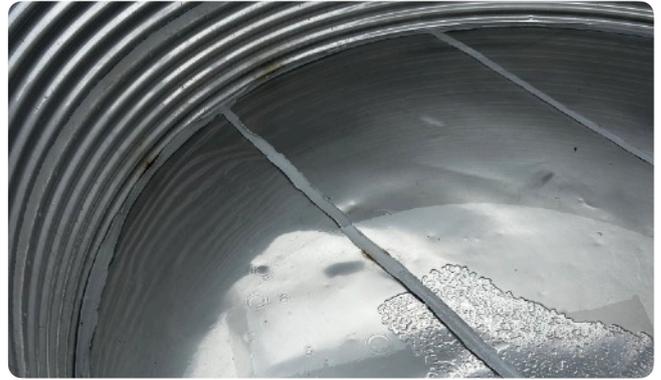
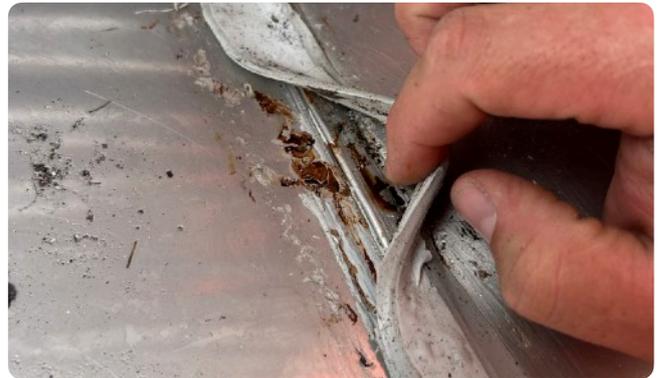
1. Cut away the loose silicone using a plastic scraper, copper or stainless blade or spatular.
2. Clean the area thoroughly with isopropyl alcohol.
3. Allow to dry fully before applying a fresh bead of pool-grade silicone.
4. Massage in removing any air bubbles.
5. Smooth using a wet finger or finishing tool.
6. Allow to cure fully (usually 24–48 hours).
